MONITORING BENDING FATIGUE IN CARBON FIBER/EPOXY COMPOSITE STRANDS: A COMPARISON BETWEEN MECHANICAL AND RESISTANCE TECHNIQUES

Ingo Weber and Peter Schwartz*

Fiber Science Program and Field of Mechanical Engineering, Cornell University, Ithaca, NY 14853, USA

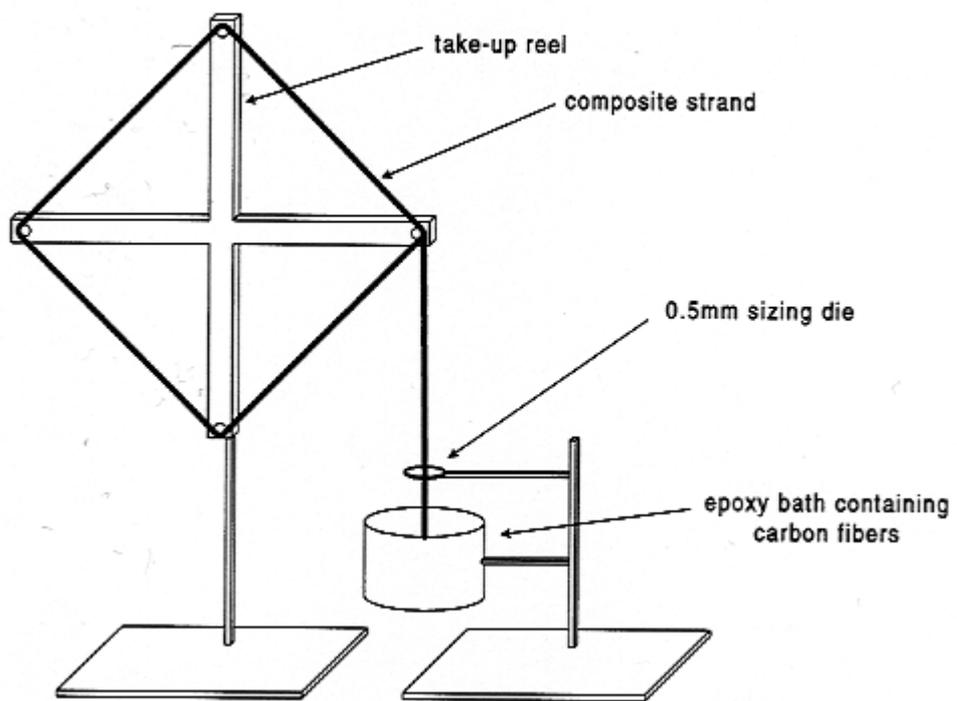
The impregnated strand was pulled through a 0.5 mm wire sizing die (Bettner Wire Coating dies, Inc., Columbus, IN), as illustrated in Figure 1, creating a strand with an approximate fiber volume fraction of 0.52. When the Ag-painted region reached the die, the die was opened to allow the slightly thicker region to pass freely through, and closed immediately behind. Figure 2 is a photomicrograph of the end of the strand

Figure 1. Schematic of sample preparation method.

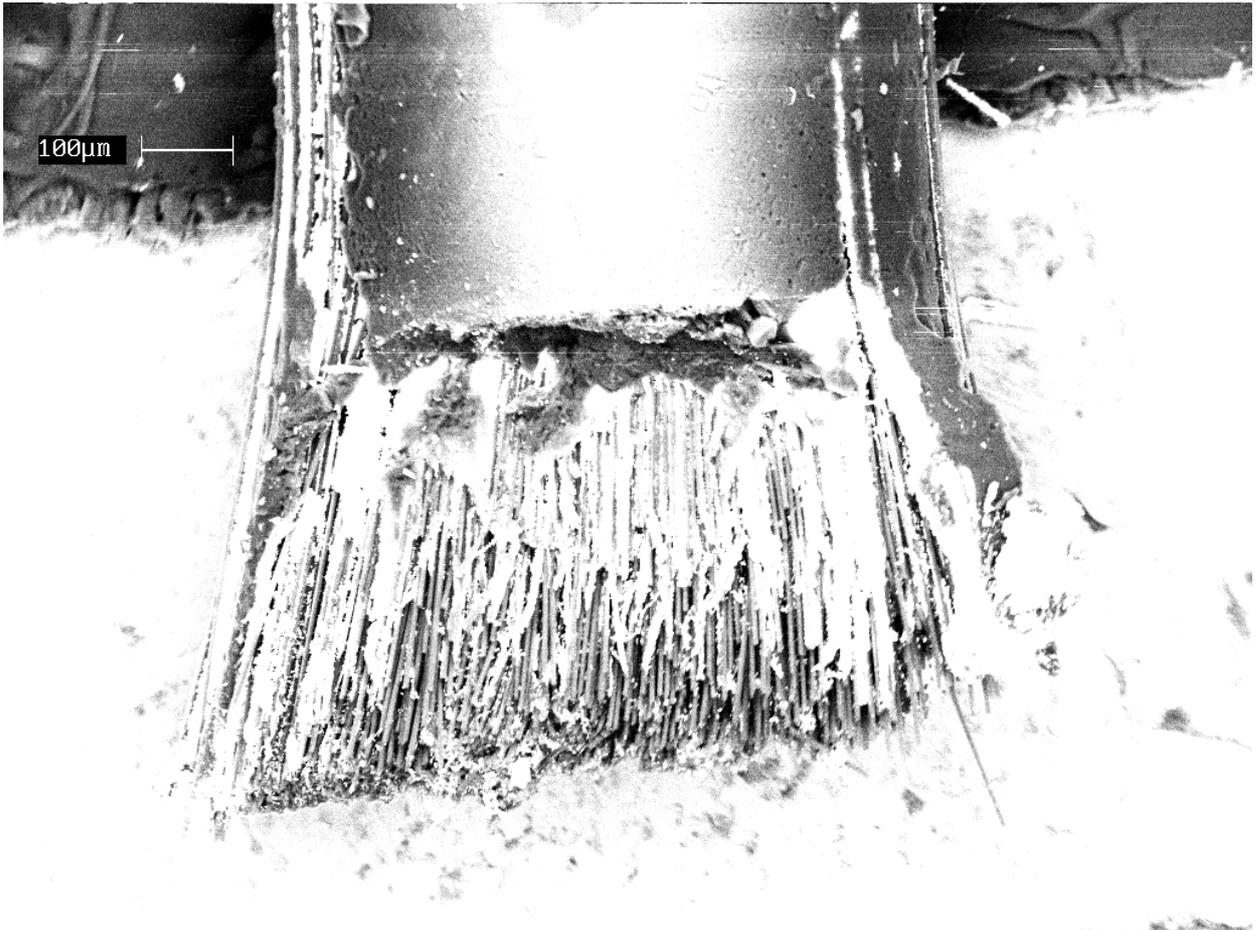
Figure 2. Silver-painted carbon fiber/epoxy strand.

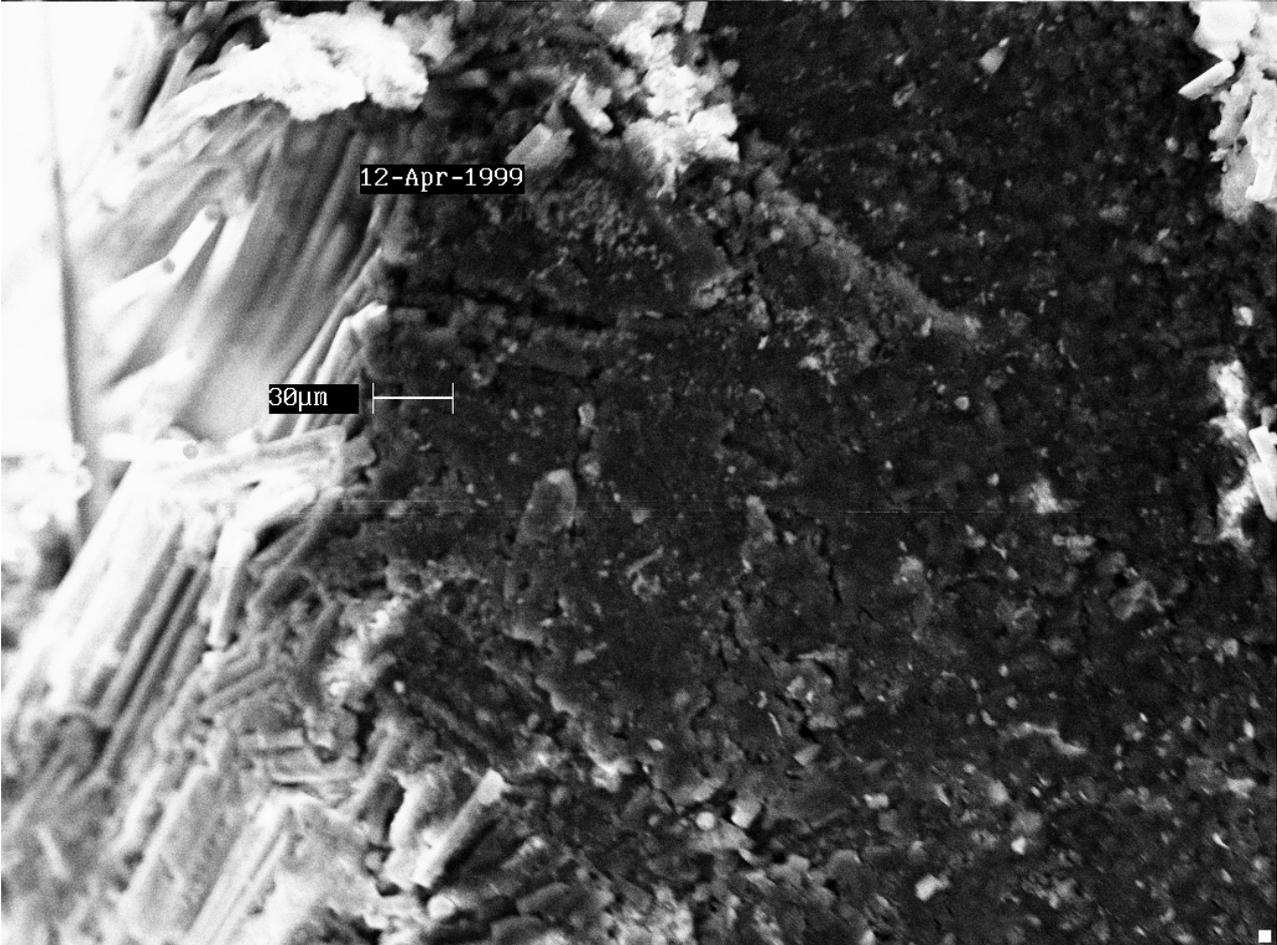
with part of the epoxy removed, while Figure 3 is an image of the cross section of an impregnated strand illustrating excellent epoxy impregnation. Mechanical tests yielded the following strand mechanical properties: ultimate stress, $\sigma_{um} = 1900$ MPa, ultimate strain, $\epsilon_{um} = 0.025$, and initial modulus, $E_m = 123$ GPa.

Figure 3. Cross-section of carbon fiber/epoxy strand.

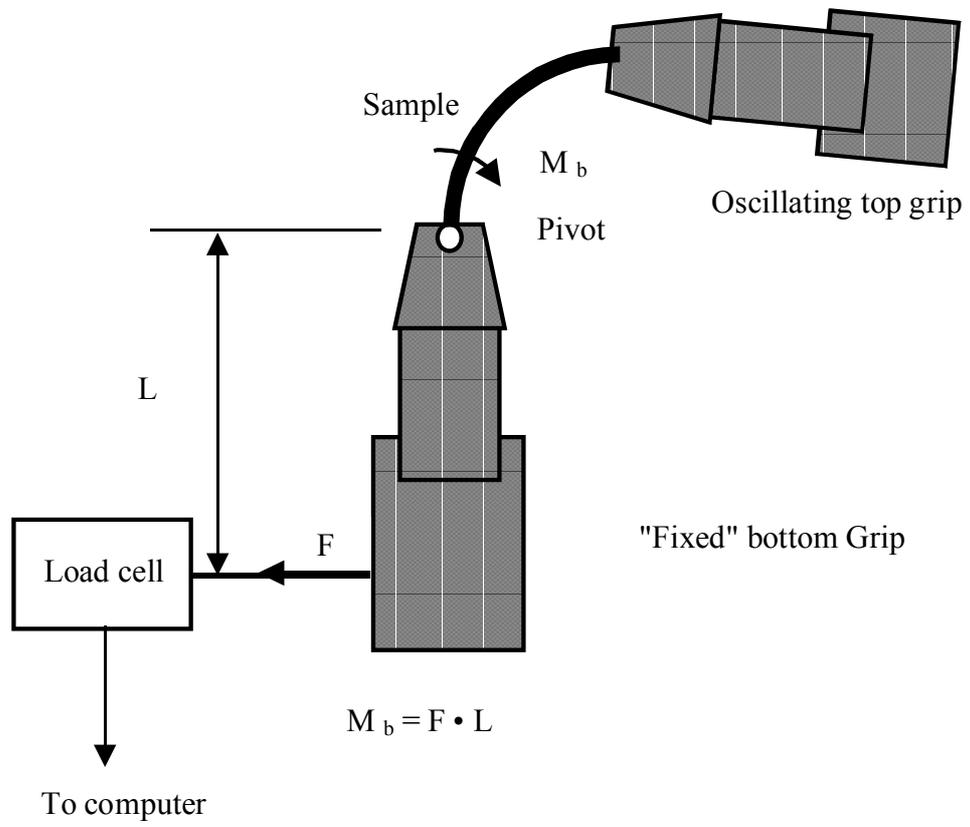
A specially constructed bending fatigue tester, described in [3] and detailed in [4], was used for these experiments. The sample was gripped in two pin vices, one pinned and one attached to a crank arm, with the Ag-coated section extending through the bottom where electrodes were soldered on. A constant, 10 mA current was passed through the sample and the voltage monitored, the resistance was determined using Ohm's Law, $R = V/I$, $I = \text{constant}$. A curvature, $\pm 0.09 \text{ mm}^{-1}$ (surface strain ± 0.0225), was imposed and the applied moment was detected by a load cell (Schaevitz Engineering, Pennauken, NJ) connected to the pinned grip via a lever arm, as illustrated in Figure 4. Referring to Figure 4, the pinned grip is actually attached to the tester only at the pivot point. The grip holder is attached to a load cell a few centimeters down from the pivot point. Assuming that there are no frictional or inertial forces, the bending moment, M_b , is, at any time, balanced by the force, F , exerted on the load cell by the lever arm. Knowing the distance, L , from the pivot point to the lever arm, the bending moment may be calculated as $M_b = F \cdot L$.

Figure 4: Schematic of fatigue tester and load cell.

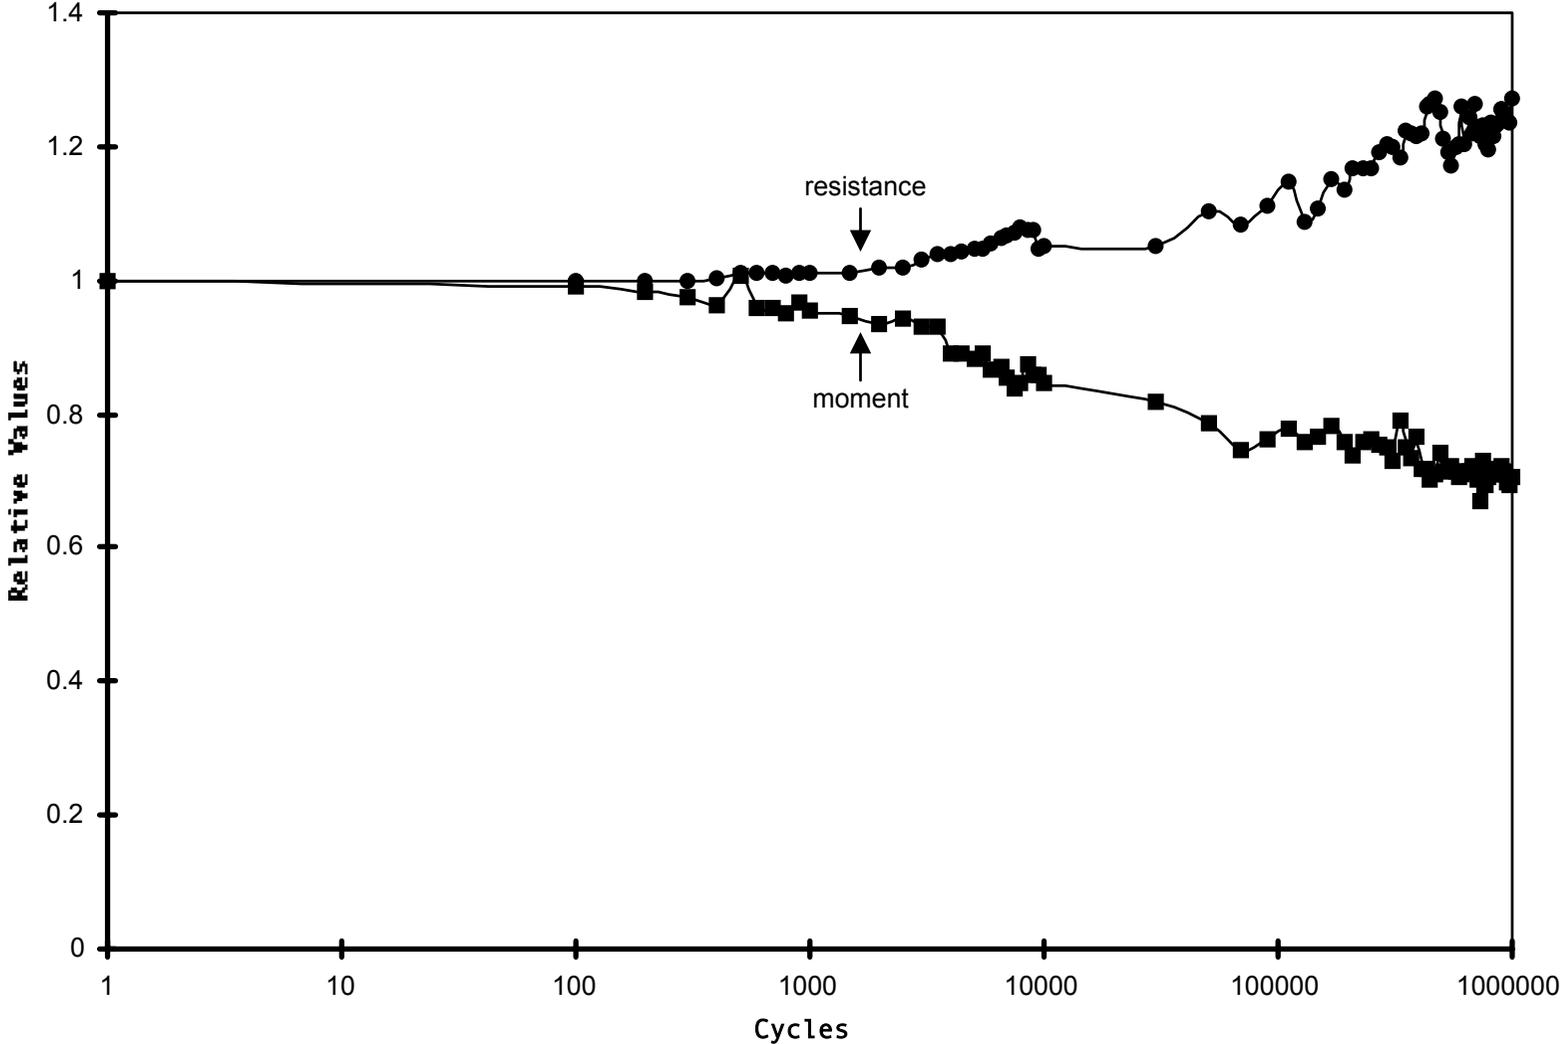
Figure 5 is a typical plot of the experimental data for normalized bending moment, B/B_0 , and normalized resistance, R/R_0 , where B_0 and R_0 are the bending moment and

resistance measured after 10 cycles. Both curves begin to diverge at approximately the same point in time indicating that the resistance is as sensitive to fatigue damage as is the measurement of mechanical degradation. In Table 1 the values for relative bending moment and resistance after 10^6 cycles are presented. A great deal of variability may be seen among the tests, which is typical of lifetime testing. The strands did not completely fail because, as the outer fibers broke, the effective strand diameter decreased to the point where the applied curvature no longer produced a strain in the surviving fibers exceeding their failure strain. Hence the fibers remained intact with no further loss in bending modulus or resistivity.

Figure 5: Graph of data from a typical fatigue experiment.

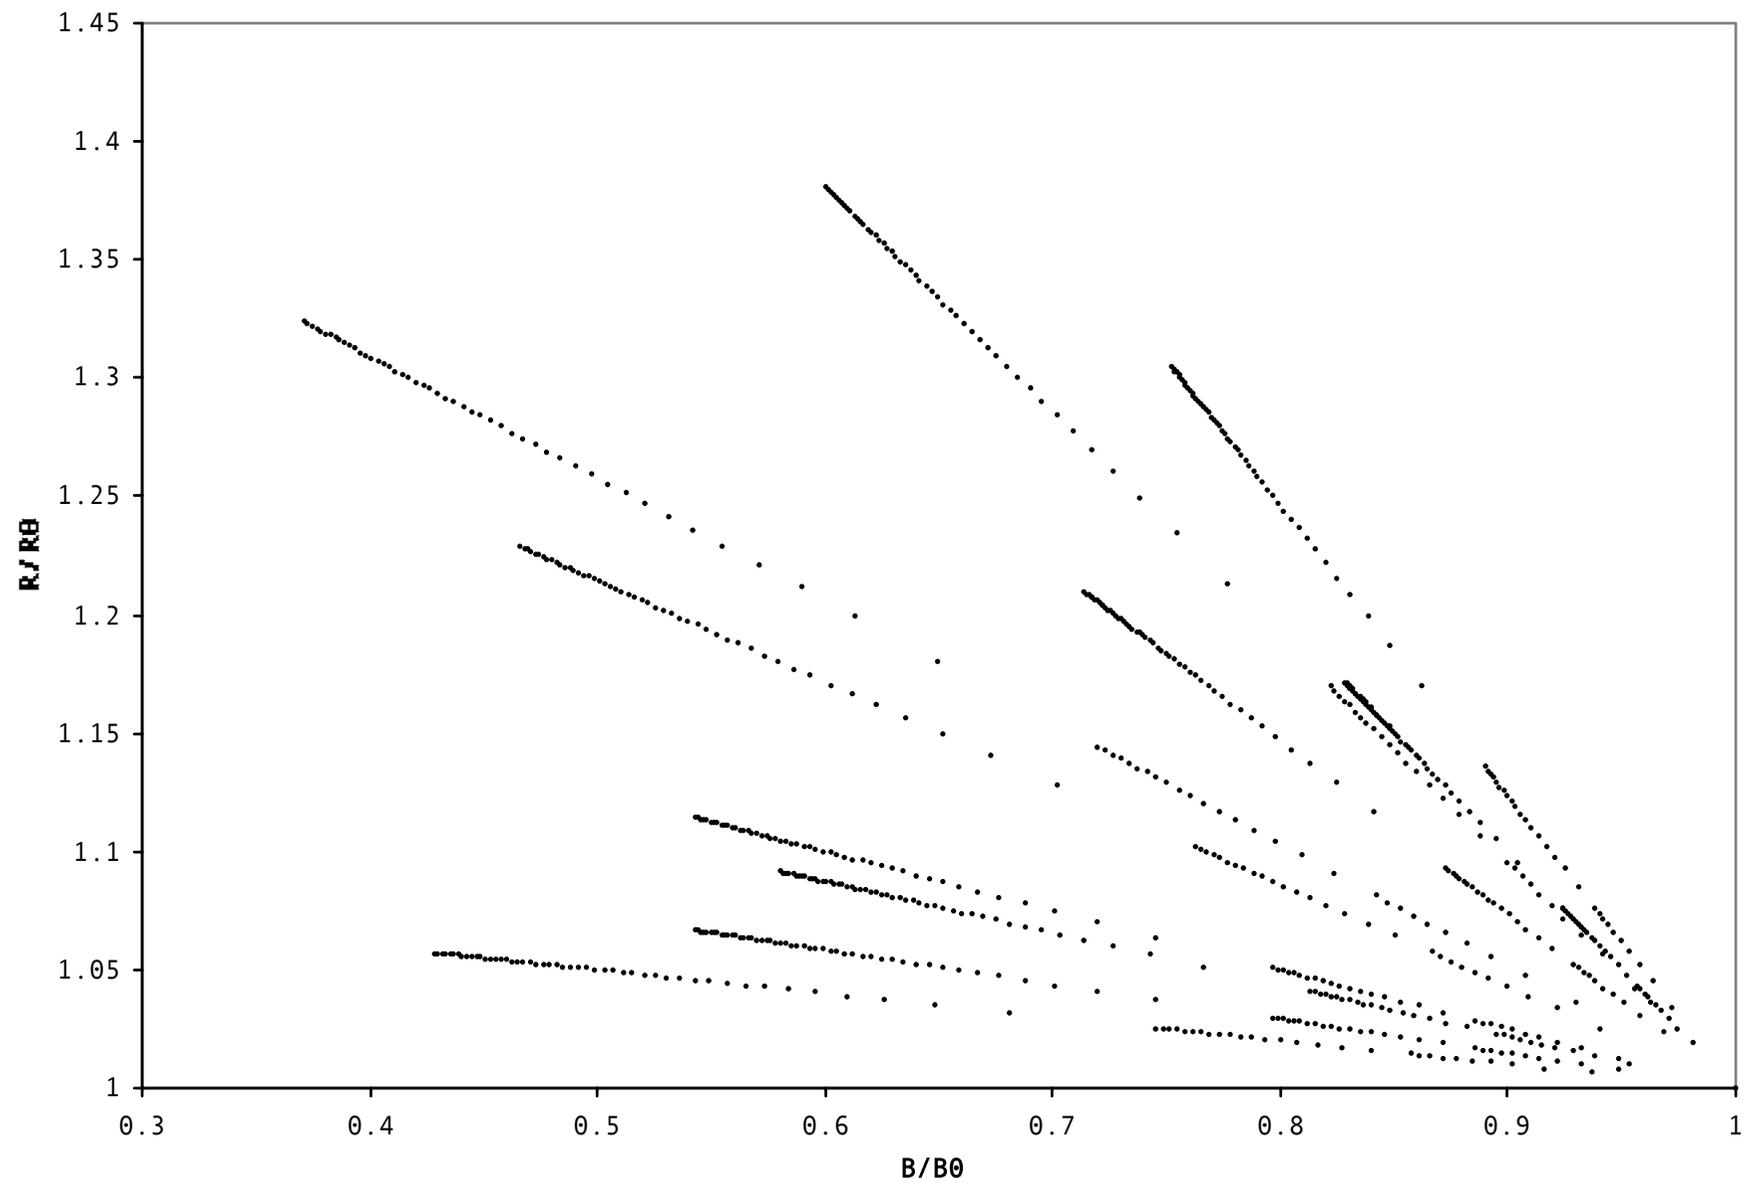
In Figure 6 are presented the normalized resistance vs. normalized moment trajectories for each of the ten trials. It can be observed that the trajectory for each trial is linear but the aggregate cannot be fitted by a simple linear relationship. The variability in the data among samples result both from the inherent variability of fatigue tests as well as that do to the variability in paths the current can take as fibers are broken as well as different. Because one cannot be assured that the misorientation among fibers within a strand nor the distribution of the matrix is identical, there is no reason to expect that the experimental trajectories would lie one atop another.

Figure 6: Normalized resistance (R/R_0) vs. normalized bending moment (B/B_0) for all fatigue experiments.
